**NASHUA RIVER BASIN  
FITCHBURG, MASSACHUSETTS**

**McTAGGARTS POND DAM  
MA 00879**

**PHASE I INSPECTION REPORT  
NATIONAL DAM INSPECTION PROGRAM**

**DECEMBER 1979**

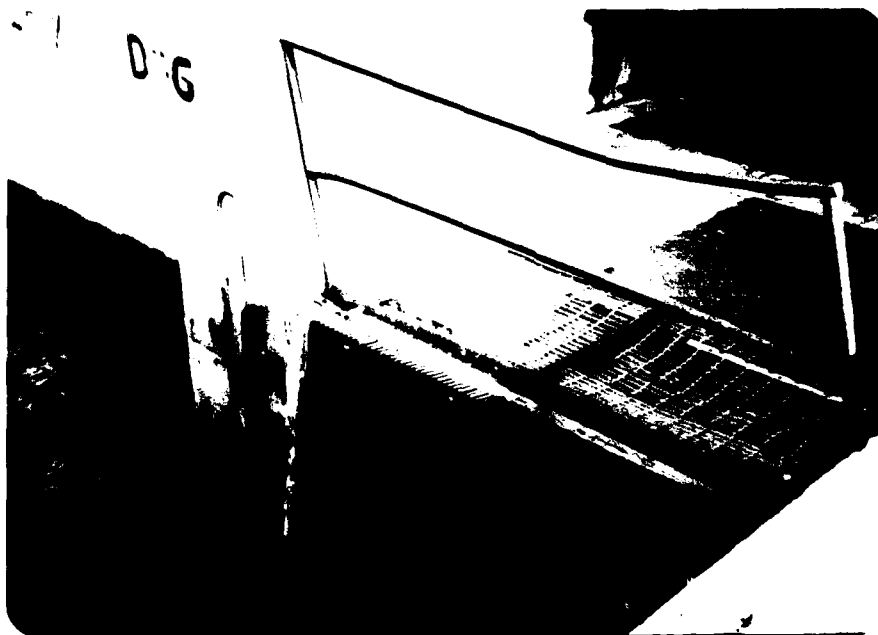
- 4.3 Maintenance of Operating Facilities. Only the downstream end of the outlet conduits, the slide gate operating mechanism, and the pulling ring and beam for the low level outlet were visible at the time of the inspection. The discharge pipe appears to be in good condition. The slide gate operating mechanism is slightly rusted but is reportedly operable. The low level outlet pulling ring and beam is heavily weathered wood with a steel loop bolted to the top. This outlet has not been used since 1956 (see photograph No. 5).

**NO. 5 VIEW OF LOW LEVEL OUTLET  
CONTROL AND MAIN INTAKE TRASH RACK**

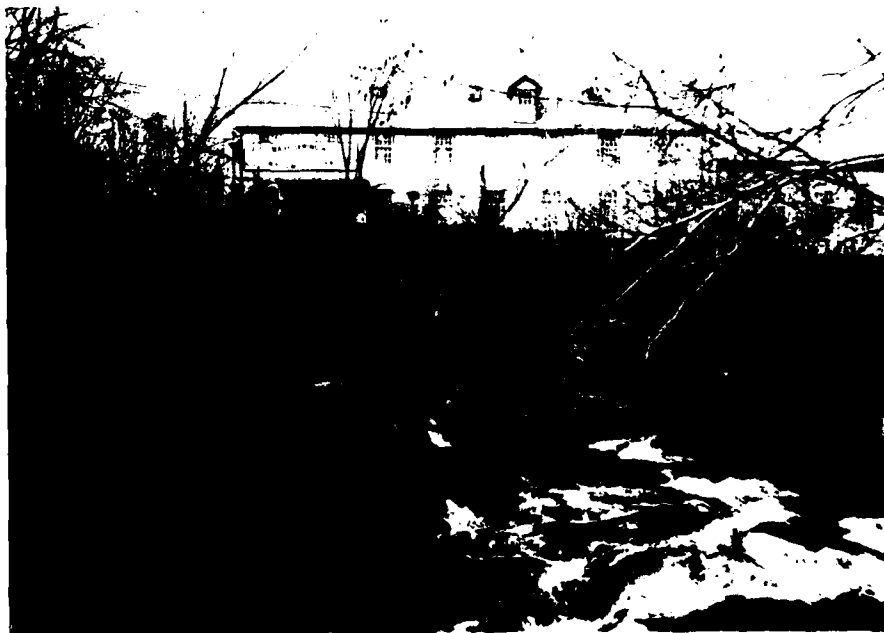
**NO. 12 UPSTREAM VIEW OF CHANNEL RESTRICTION BENEATH MILL**
